DEER VALLEY 4wd MEADOW RESTORATION and BLUE LAKES ROAD MAINTENANCE PROJECT

HYDROLOGY REPORT

July 14, 2015

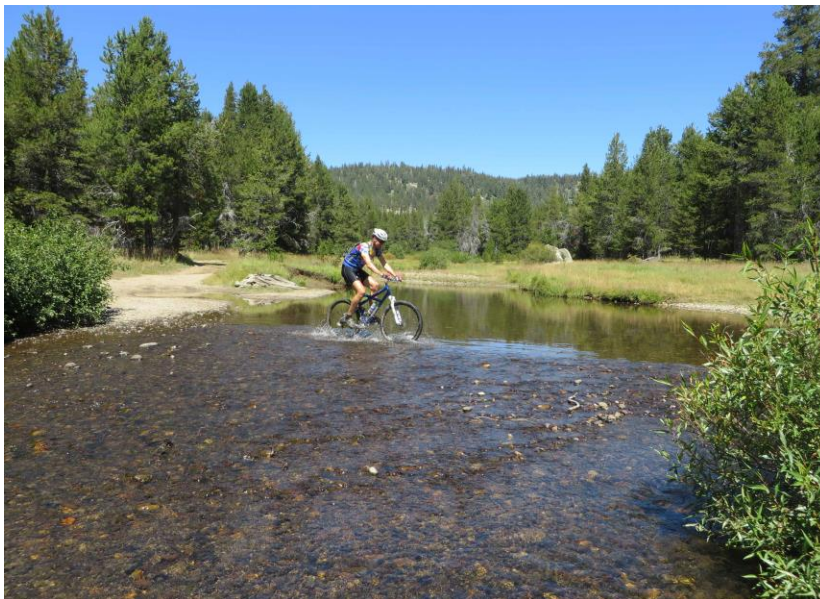
Trail 19E01 crosses Deer Creek.

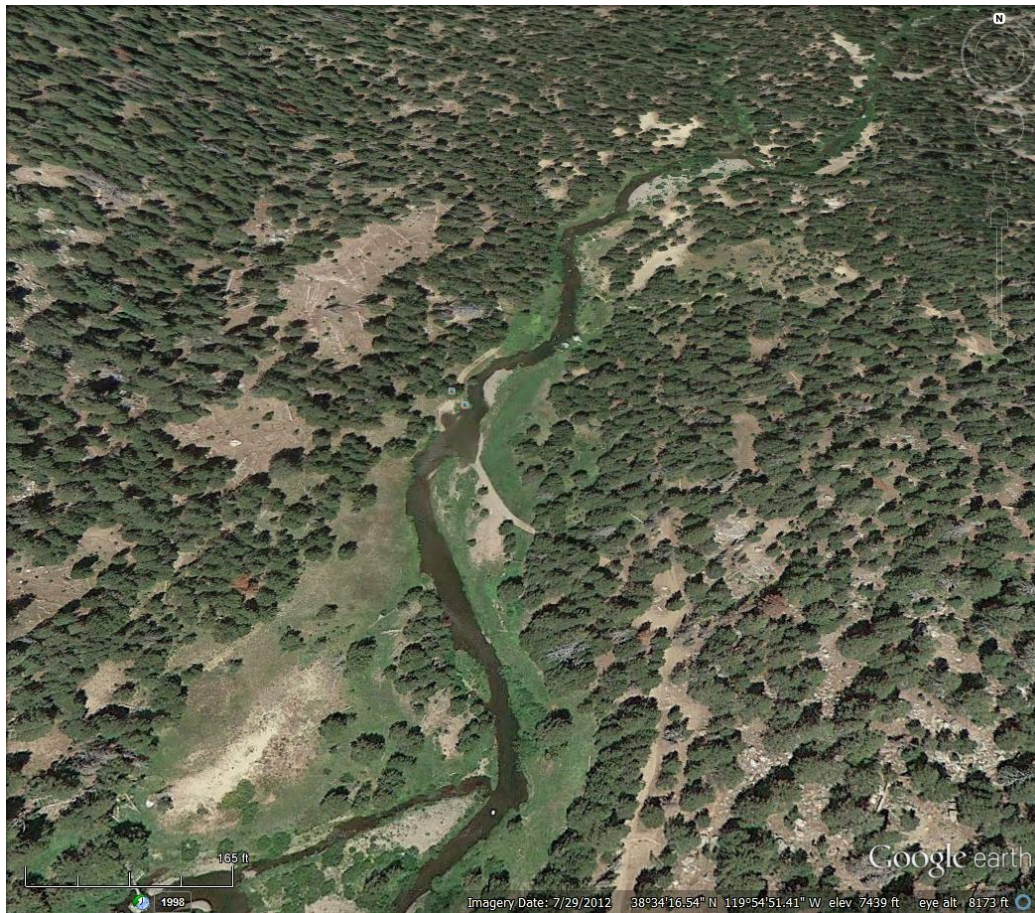
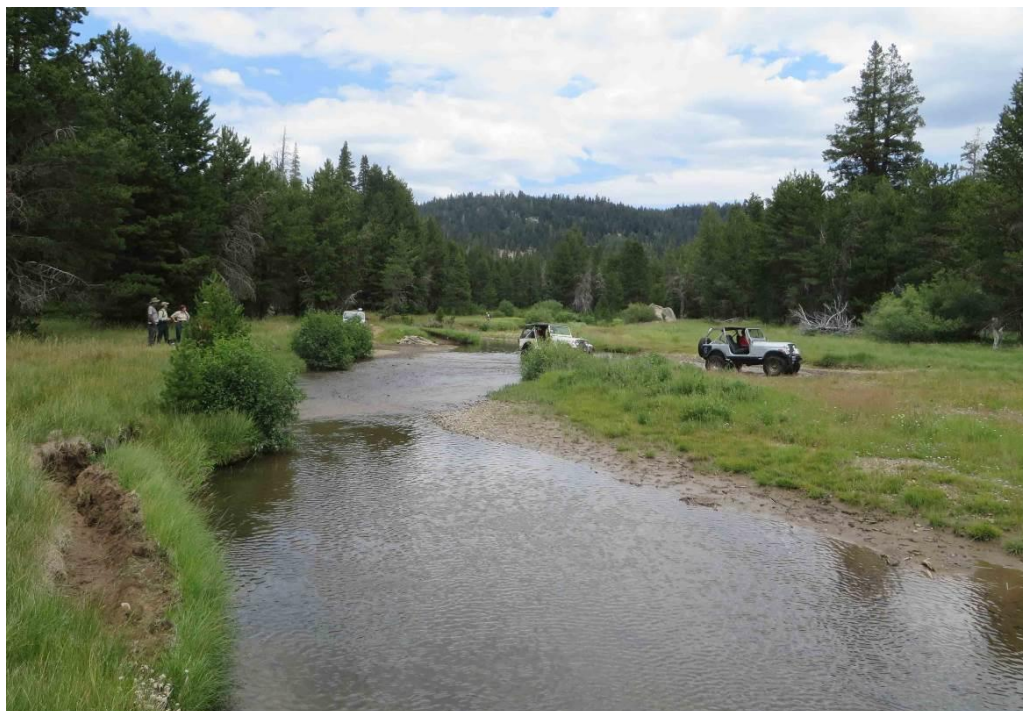
Figures 4 and 5. Aerial view and ground view of the Deer Valley 4wd Trail (19E01) at the crossing of Deer Creek and Meadow 09N83-2 in Deer Valley.

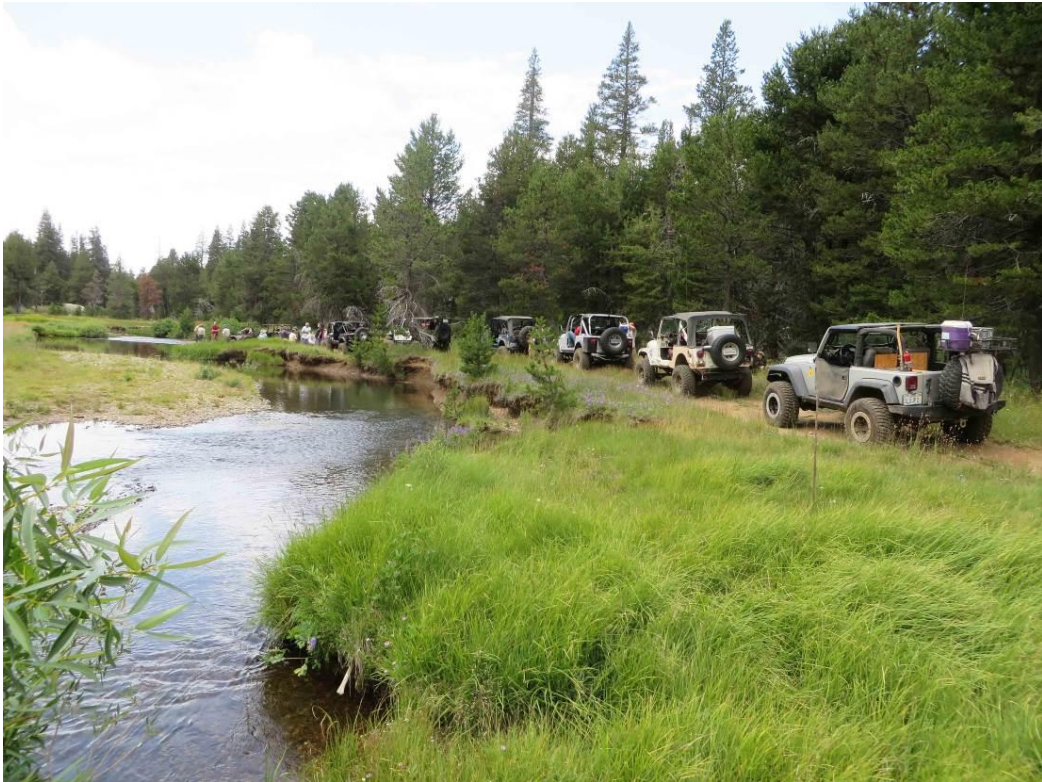
Figure 6. A segment of the Deer Valley 4wd Trail (19E01) at Meadow 09N83-2 is less than 30 feet from Deer Creek.
(Aug. 2014).

- Sediment from the 250 ft. long segment of the Deer Valley 4wd Trail (19E01) that is less than 30 feet from Deer Creek would continue to erode into the stream. This is because the re-routing of this segment of the trail away from the stream, as well as the restoration of the 250 ft. long road segment, would not occur.

- Sediment from the 250 ft. long segment of the Deer Valley 4wd Trail (19E01) that is less than 30 feet from Deer Creek would no longer reach the stream. This is because this segment of the trail would be re-routed away from the stream, and restoration of the abandoned road segment would occur.

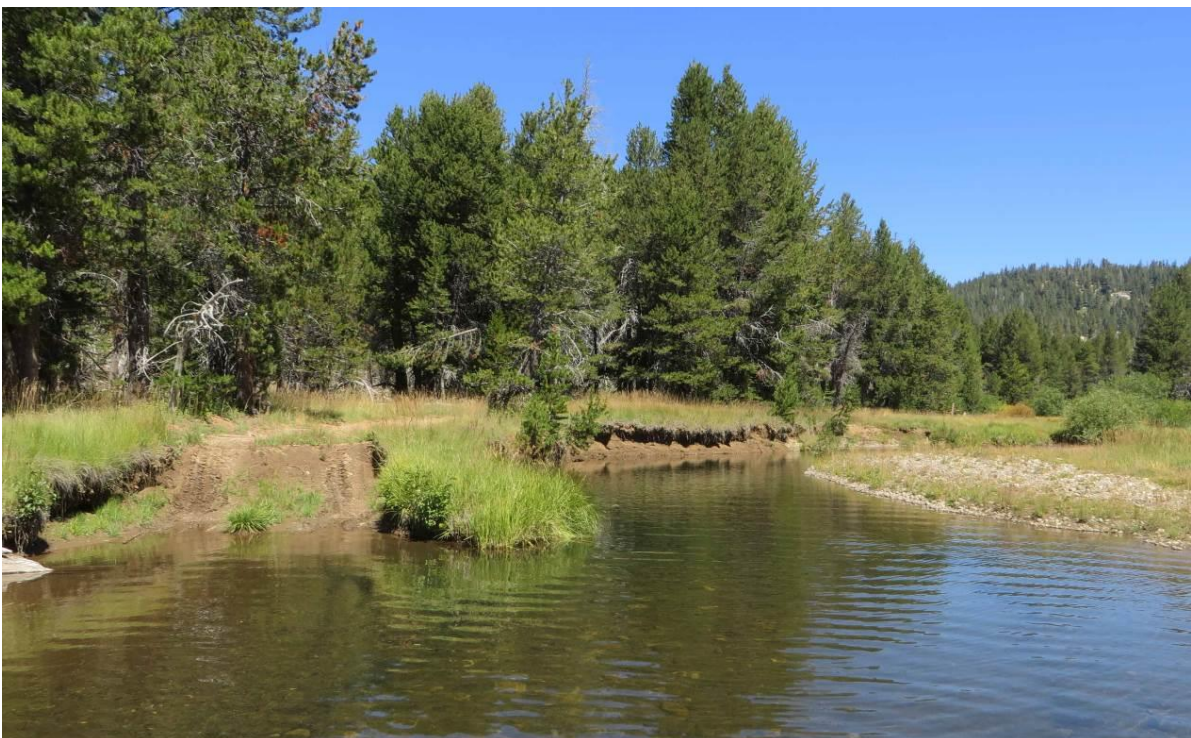
Figure 7. Eroding streambank of Deer Creek at Meadow 09N83-2. (August 2014).

- Several locations where the streambanks of Deer Creek (at Meadow 09N83-2) are denuded and eroding as a result of past OHV use would likely continue to erode. This is because the planting of vegetation and/or sod plugs on those streambanks would not occur.

- Several locations where the streambanks of Deer Creek are eroding as a result of past OHV use would be rehabilitated by planting vegetation and/or sod plugs on those streambanks.

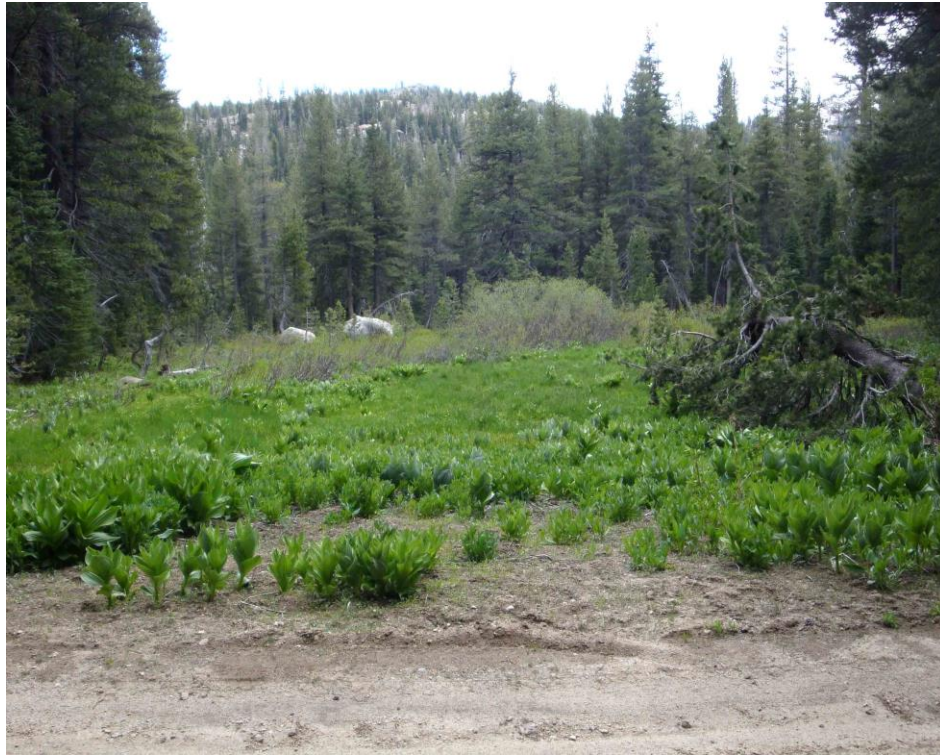
Figure 8. The Blue Lakes Road (09N01) crosses or borders a complex of small meadows. Sediment from the road is eroding into a small portion of the meadow in the bottom of this photo – this is described in Point #6 in Table 3. *June 2015.*

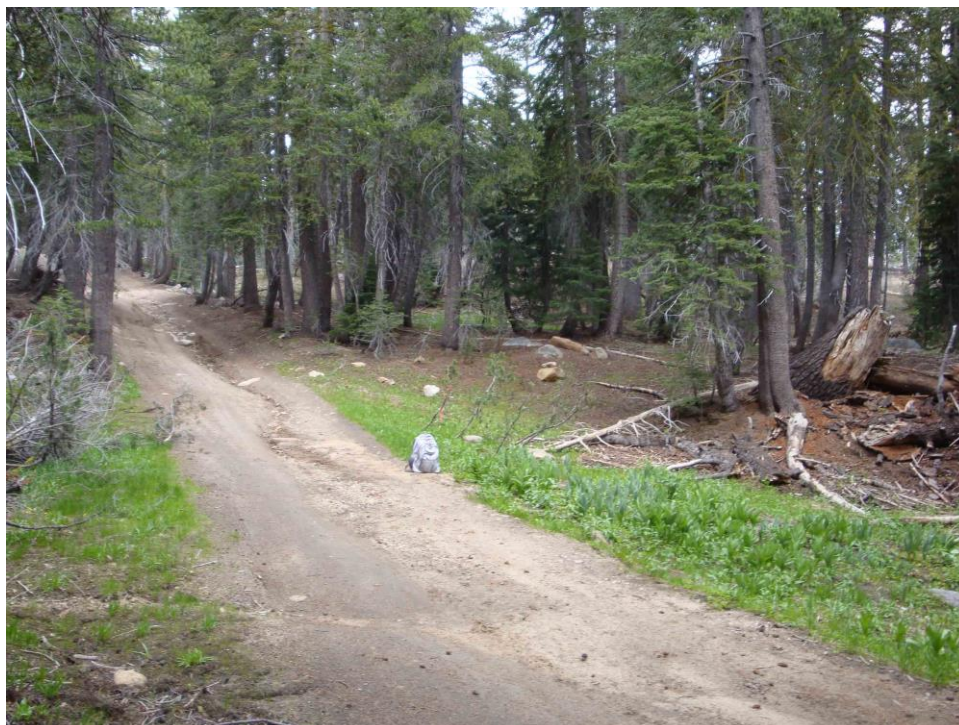
Figure 9. A 400 foot long rill in the Blue Lakes Road (09N01) delivers runoff and sediment off of the road and into a small meadow – this is described in Point #2 in Table 3. Only a portion of the rill and meadow are shown in this photo. *June 2015.*

Point	UTM coord. ⁴	Existing Condition	Repairs to road 09N01	How repairs meet Standard & Guideline #100
2	0243369 4277694	Runoff and sediment from a 400 ft. long segment of road 09N01 is reaching a narrow meadow on the south side of the road - the primary rill in the road is nearly 400 feet in length and up to 6 inches in depth. The resulting deposition of sediment from the road into the meadow has caused a portion of the meadow to become drier. (Figure 9).	Construction of 2 or 3 rolling dips in the 400 long road segment upslope of the meadow. (Example in Figure 14).	The rolling dips will divert most of the runoff and sediment from the road into the forest before the runoff and sediment reaches the meadow. This will greatly reduce the drying out of the meadow as a result of sediment from the road being delivered into the meadow.
6	0243206 4277637	The culvert underneath the road is approximately 1 ft. in diameter. As a result, the movement of surface water through the meadow is impeded, particularly during higher streamflows. A small amount of runoff and sediment from the road 09N01 is reaching a stream and a meadow adjacent to the stream. This may contribute to a portion of the meadow being less wet. (Figure 8).	Replace the existing culvert with a culvert that will pass flow and debris from the 100-year precipitation event (Example in Figure 15). Raise the height of the road surface for a distance of approximately 150-200 feet.	Most of the surface flow will be able to pass through the culvert. This will allow more surface water to reach the meadow down-gradient of the road. Most of the runoff and sediment from the road will flow away from the stream and adjacent meadow.

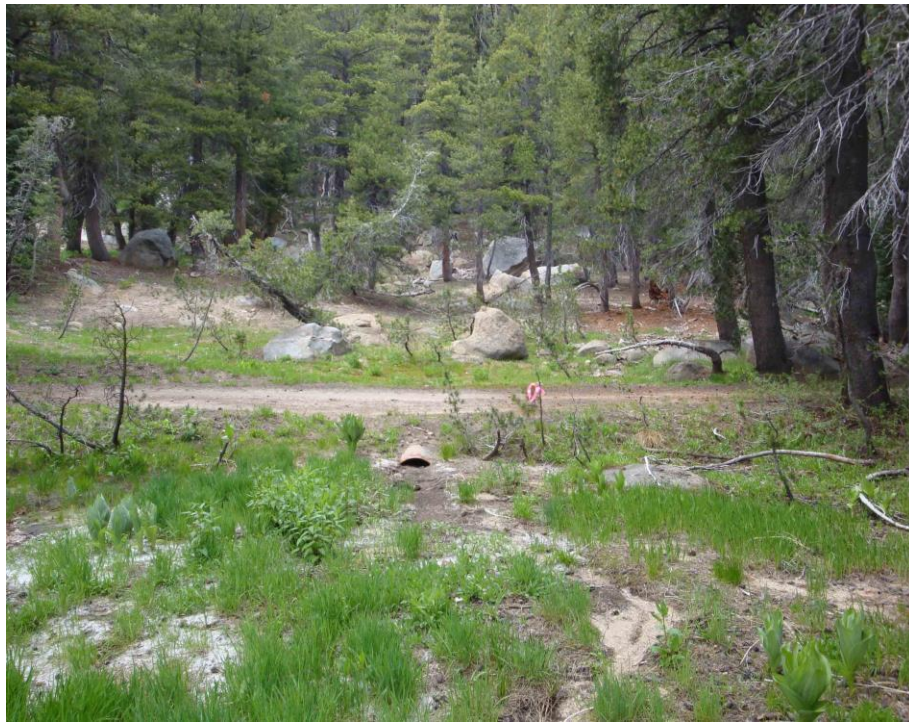
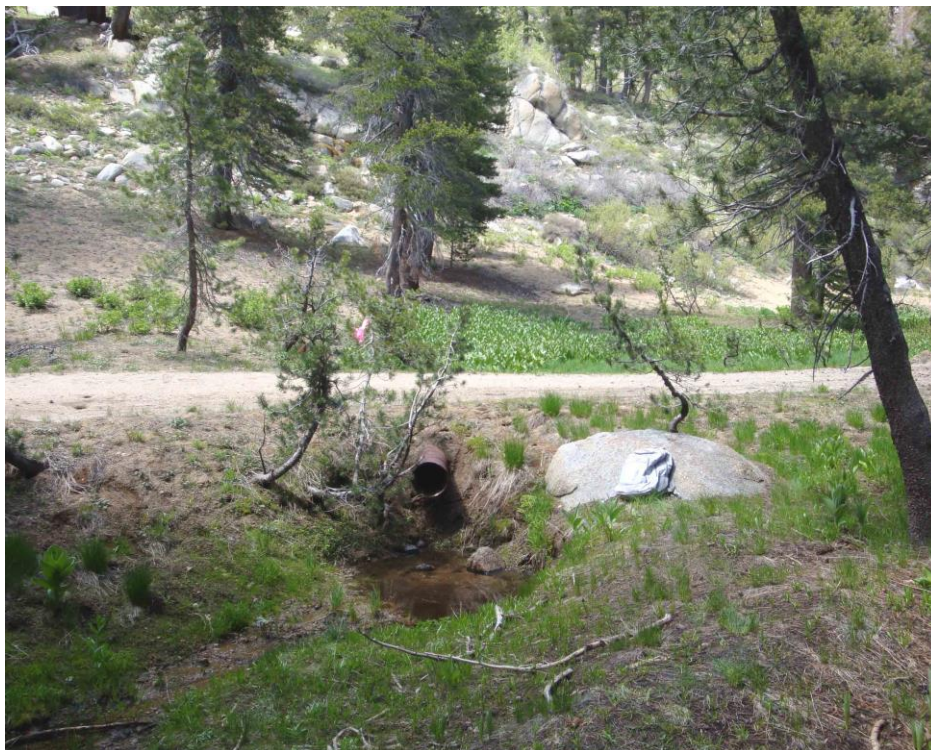
Figures 10 and 11. Several culverts on the Blue Lakes Road (09N01) are small in diameter and partially plugged with sediment. The top photo is described in Point #7 in Table 3, and the bottom photo is described in Point #8 in Table 3. *June, 2015.*

7	0243109 4277564	Runoff and sediment from road 09N01 is reaching a meadow. The resulting deposition of sediment has caused a portion of the meadow to become drier. (Figure 10).	Raise the height of the road surface for a distance of approximately 150-200 feet. Replace the existing culvert (if needed) with a culvert that will pass flow from the 100-year precipitation event.	Most of the runoff and sediment from the road will flow away from the stream and adjacent meadow. This will greatly reduce the drying out of the meadow contributed by sediment from the road into the meadow.
8	0242913 4277481	The culvert underneath the road is approximately 1 ft. in diameter and the inlet is almost completely plugged with sediment. As a result, much of the surface water above the road cannot reach the meadow below the road. There is a 2 ft. vertical drop at the outlet of the culvert - this is causing erosion of the stream channel. A small amount of runoff and sediment from road 09N01 is reaching a stream and a meadow adjacent to the stream. The resulting deposition of sediment has caused a portion of the meadow to become drier. (Figure 11).	Replace the existing culvert with a culvert that will pass flow from the 100-year precipitation event. Place riprap at the outlet of the culvert. Raise the height of the road surface for a distance of approximately 100-150 feet.	Most of the surface flow will be able to pass through the culvert. This will allow more surface water to reach the meadow below the road. Most of the runoff and sediment from the road will flow away from the stream and adjacent meadow. This will greatly reduce the drying out of the meadow as a result of sediment from the road into the meadow.

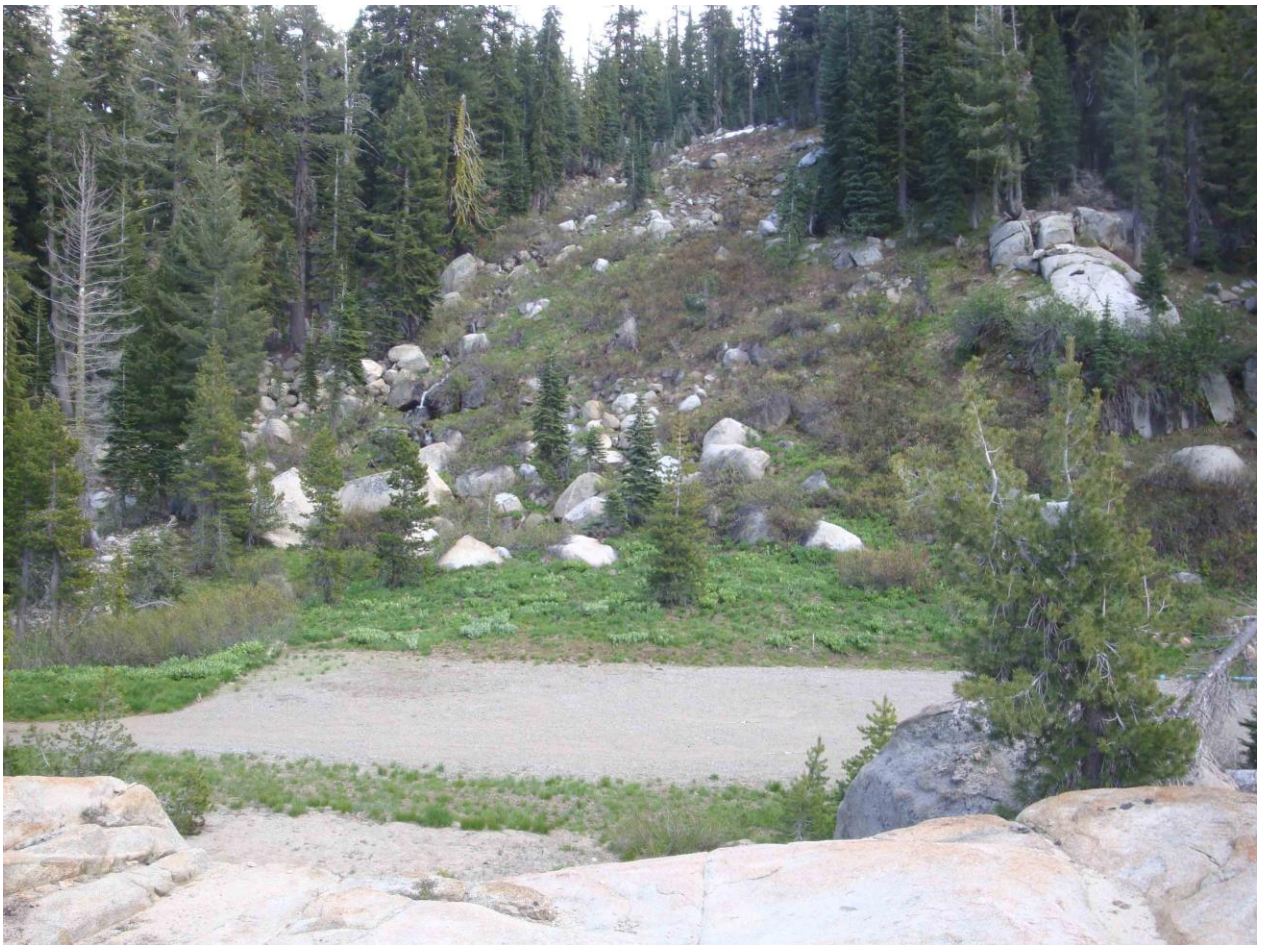
Figure 12. Parking area at the end of the Blue Lakes Road (09N01). (June 2015).

The parking area was delineated and covered with gravel as part of one of the 4e conditions for the Mokelumne River Project (FERC No. 137) licensed to PG&E in 2001. No repairs were prescribed for this parking area under Alternatives 1, 3, and 4 for several reasons:

- *The parking area currently shows no signs of accelerated erosion.*
- *Runoff from the slope on the south side of the parking area (top of photo) drains off of the parking area in several directions – there is no evidence of impoundment of surface water on the parking area.*

- *The area of remnant meadow vegetation below the parking area is very small (approximately 0.04 acres). Although this small area of meadow vegetation may be impacted to some degree from restricted movement of subsurface water underneath the parking area, the impacts to the remaining meadow vegetation surrounding the parking area are negligible.*

- *The parking area has negligible effect on the hydrologic connectivity of the entire meadow complex along the last 0.8 miles of road 09N01. This is because the parking area is very small (approximately 145 feet in length and 45 feet in width, which translates to an area of 0.15 acres) and is located at the end of the road.*

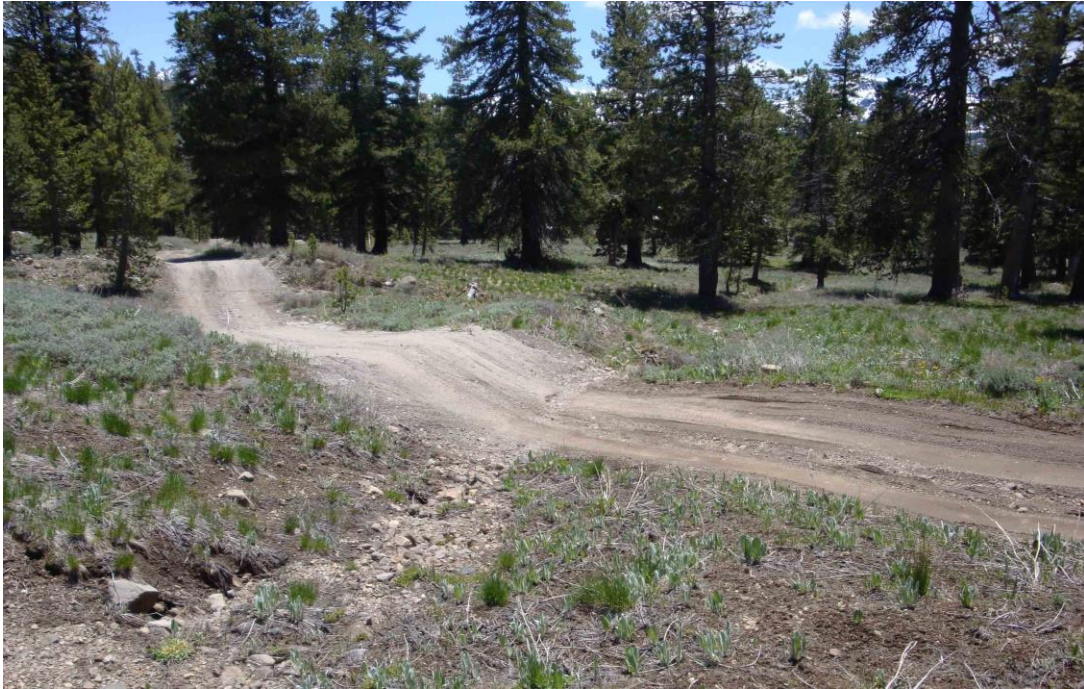
Figure 14. An example of a rolling dip in a road. Surface water flows down the road from the right to the left, and then flows off of the road at the base of the rolling dip.

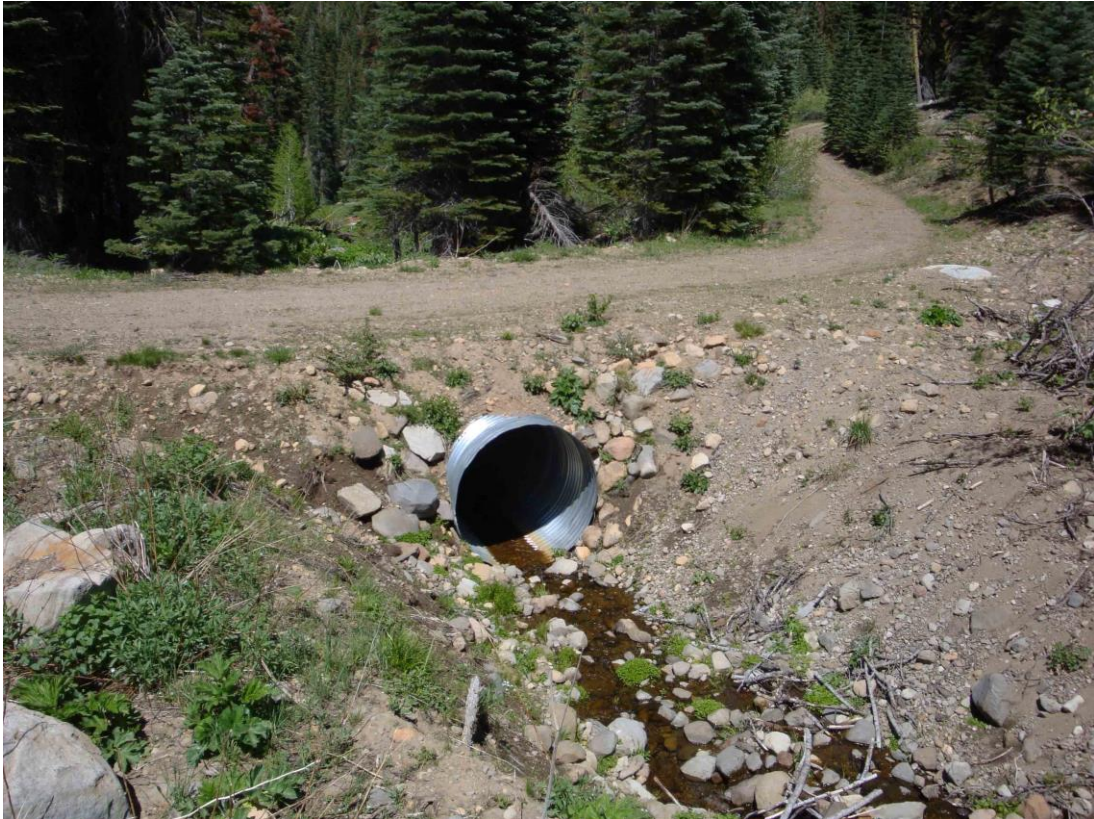
Figure 15. An example of a culvert that can pass the flow that results from a 100-year precipitation event.

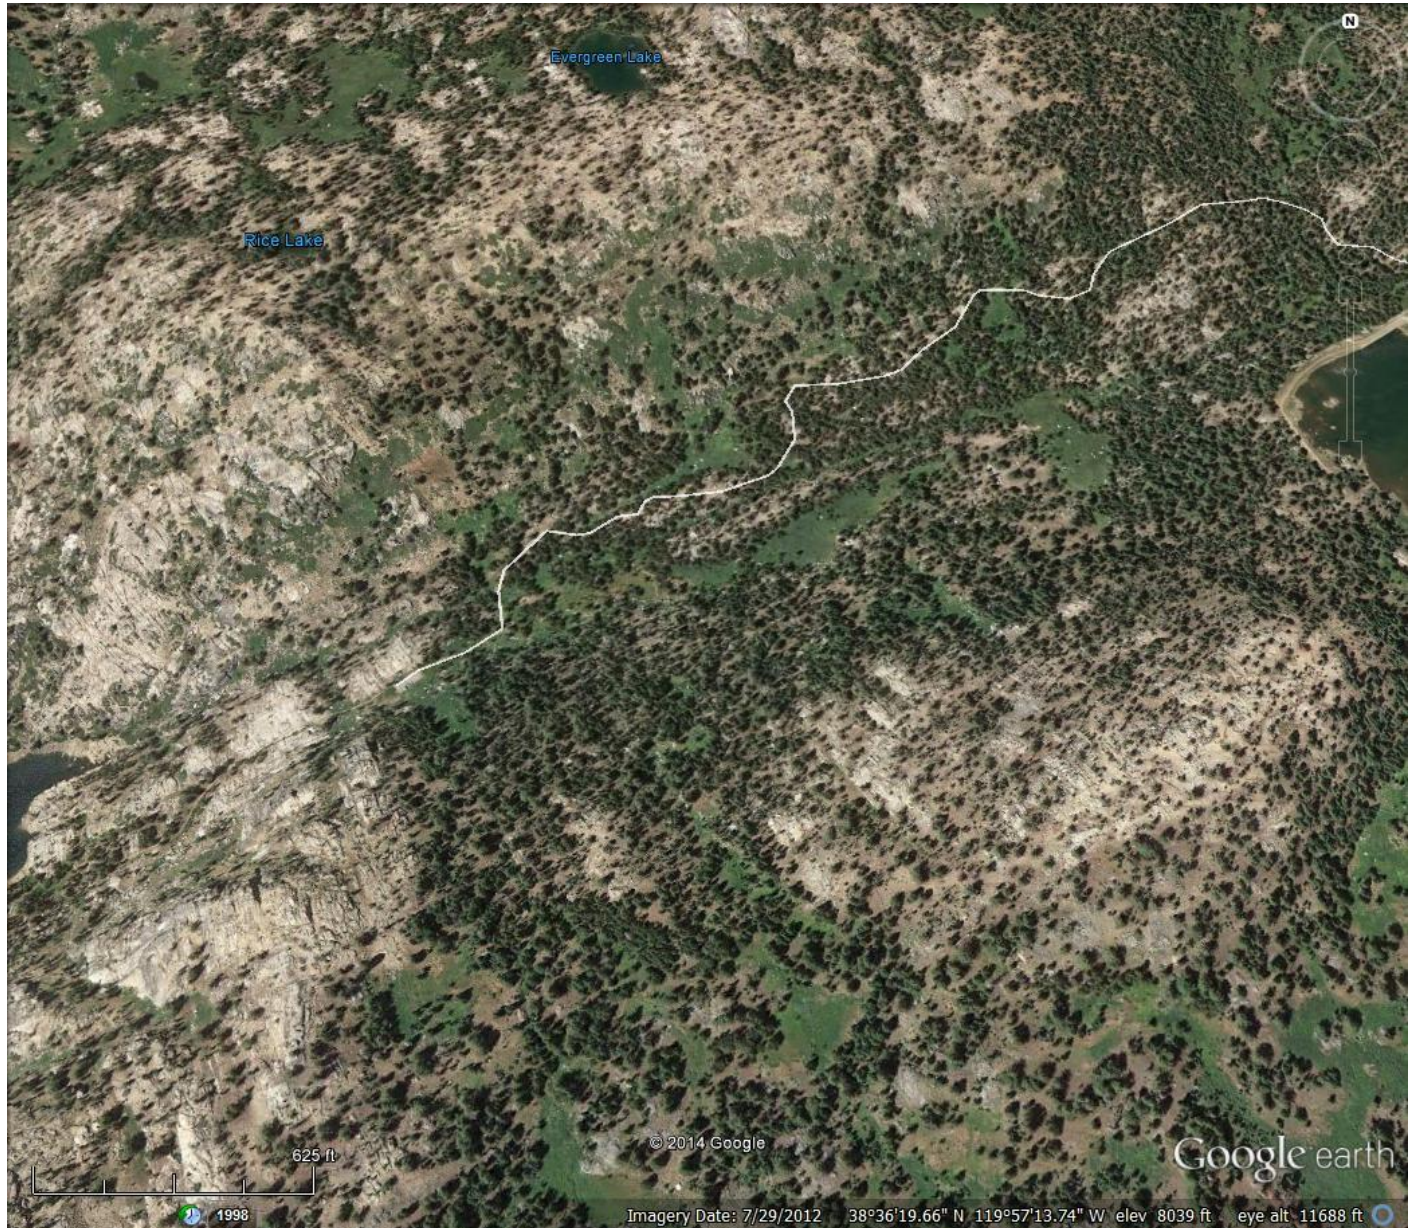
Figure 16. Aerial view of the landscape surrounding the Blue Lakes Road (09N01) to the west of Twin Lake.

The road is shown as a white line. The western part of Twin Lake is on the right edge of the photo, and the eastern part of Meadow Lake is on the left edge of the photo. The white areas are outcrops of granitic rocks, and most of the dark green areas without trees are meadows or areas of alder and other vegetation.

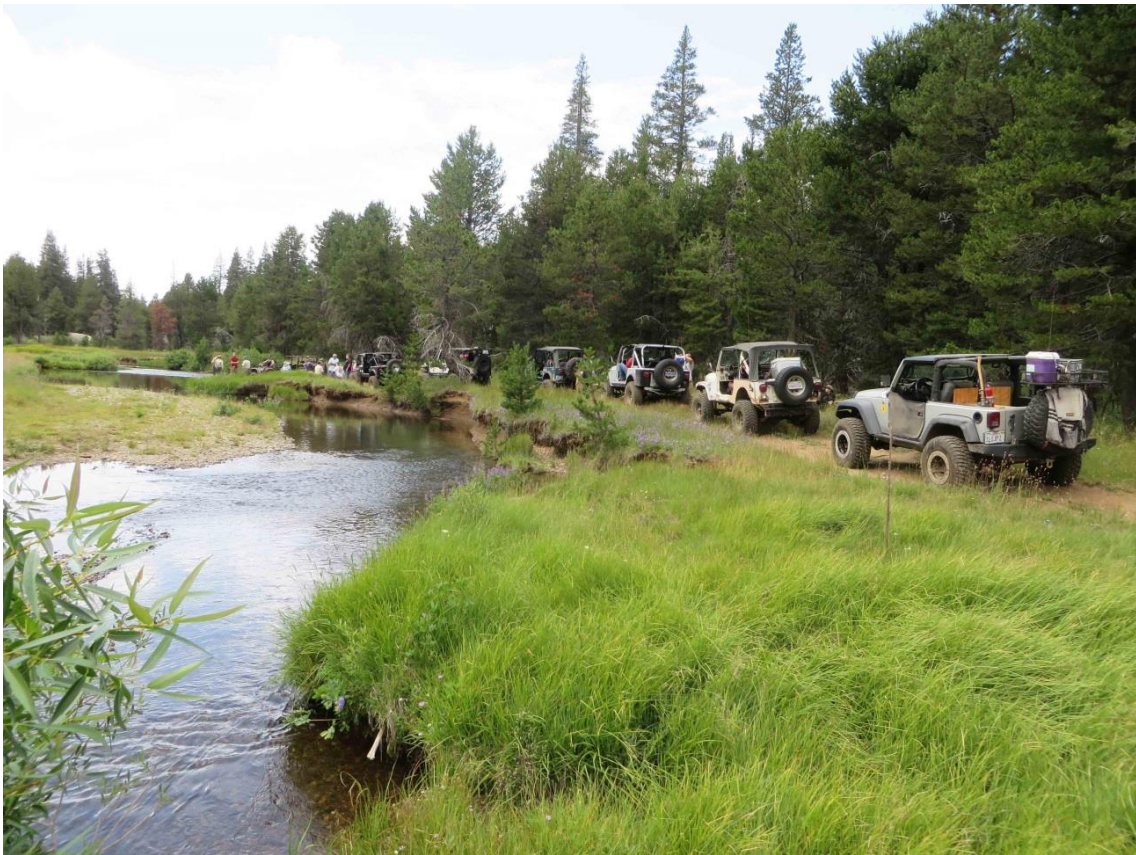
Figure 1. A segment of route 19E01 (09N83) borders Deer Creek and meadow 09N93-2 (19E01-2). The erosion of the stream channel at this location is at the outside of a meander bend.

- Route 19E01 (09N83) is not entrenched into the meadow, there was no water ponded in the road or flowing down the route, and the route occurs in less than 15 percent of the length of the meadow. This means that route 19E01 (09N83) is not intercepting and diverting surface and/or subsurface water from the meadow and routing the water away from the meadow such that the meadow has decreased in size and/or wetness. In addition, the amount of runoff from route 19E01 (09N83) into Deer Creek is negligible when compared to the flow of the stream.
- There are only a few small rills (less than 6 inches in depth) and no gullies that extend from route 19E01 (09N83) into the meadow. This suggests that runoff from route 19E01 (09N83) has not eroded sediment into the meadow such that the size and/or wetness of the meadow has been reduced.
